HELLSTROM HOME INSPECTION SERVICES, INC.

Home Inspection Report

June 29, 2010

4410 NW 19th Avenue

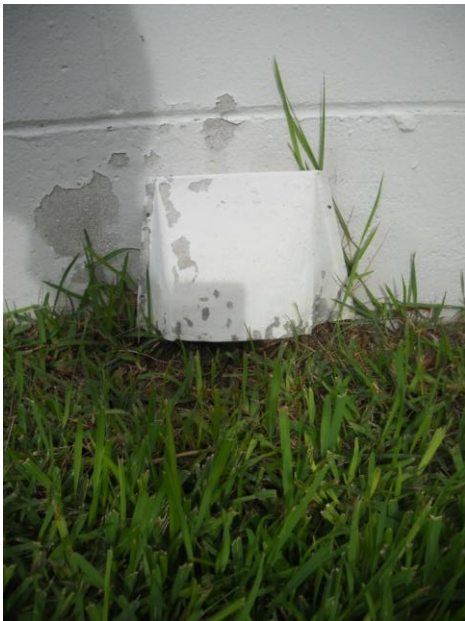
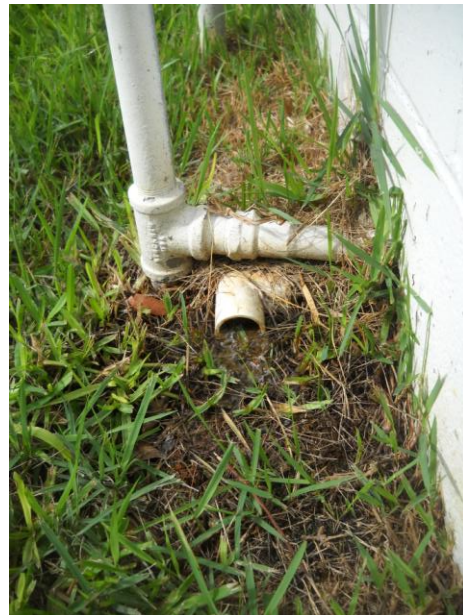
The dryer vents directly through the lower east exterior wall and there was also no airflow at the exterior vent. The dryer vent will need to be cleaned out and the vent should be elevated above grade.

Dryer vent and condensation line terminate too close to grade (east side of home)

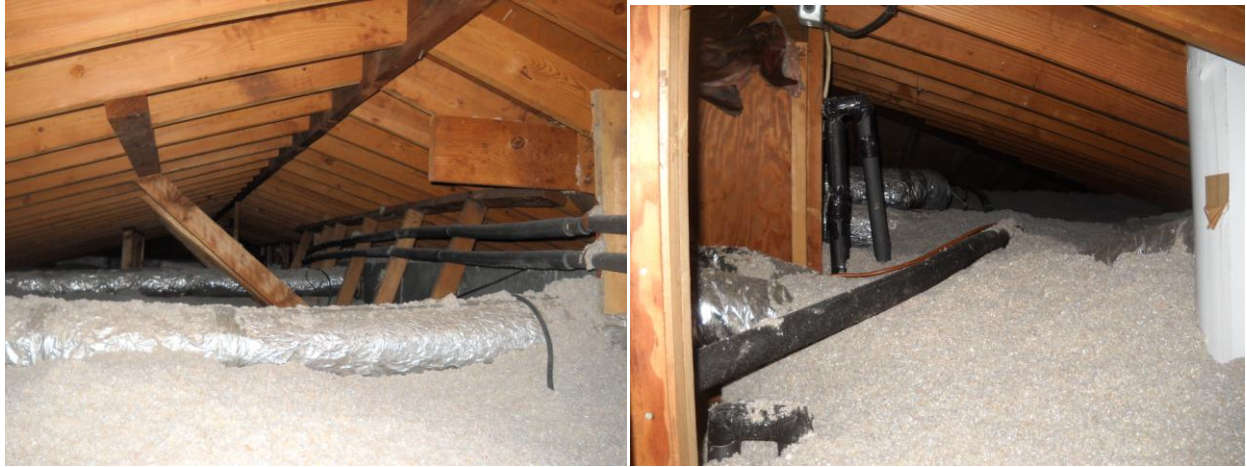
The attic has excellent loose-fill wood fiber insulation that averages about 6-10" thick, R-30 Value or better. The insulation meets National Energy Code standards for Florida attics and will really help with energy savings.

AC ductwork was in good shape where visible and new CPVC plumbing supply pipe has been routed through the attic and is properly insulated.

R-19 to R-30 loose-fill wood fiber insulation in attic - Properly insulated CPVC re-pipe through attic

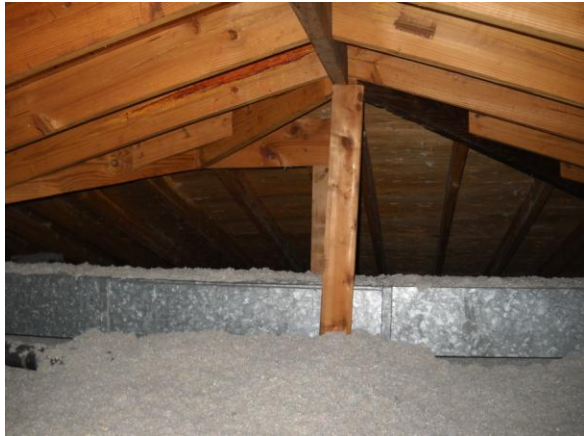
Plywood roof decking was in good condition through the attic. The roof system is raftered and showed no

Rafter system for roof

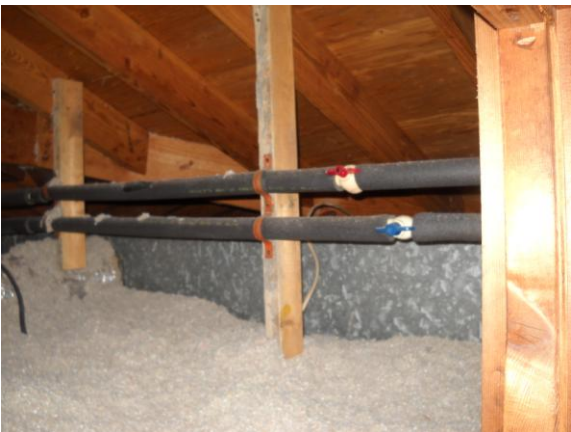
Shut-off valves in attic above laundry room

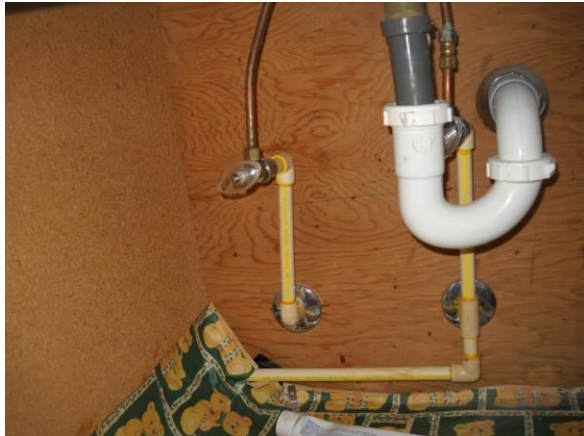
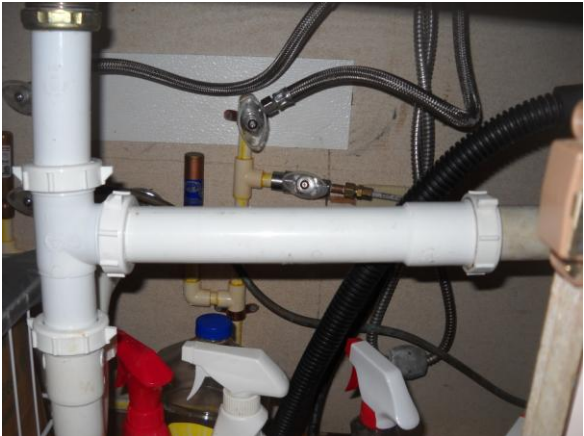
Water is supplied to and discharged to the home by public service. Water pressure was very good and all visible plumbing supply pipe has been updated with CPVC pipe routed through the attic. New pipe was likely installed in the last 10 years and should last 100+ years.

Whole house re-pipe with CPVC

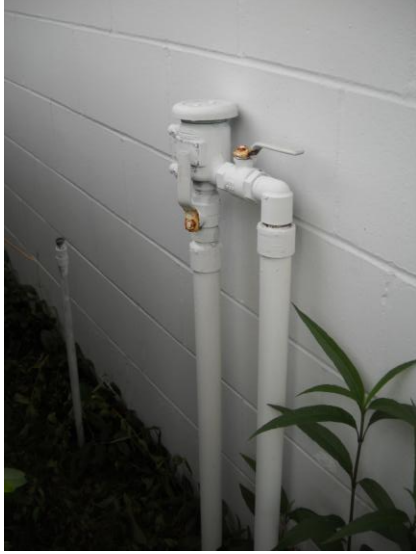
Recommend insulation backflow preventer

The RainBird irrigation system ran properly through 4 zones. I'd recommend insulating the back-flow preventer at the SW corner of the home.

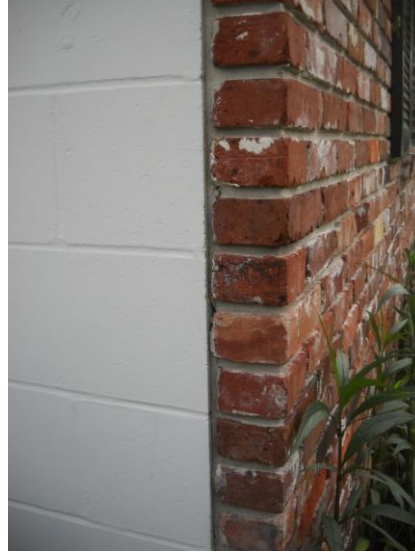
Brick face at front walls

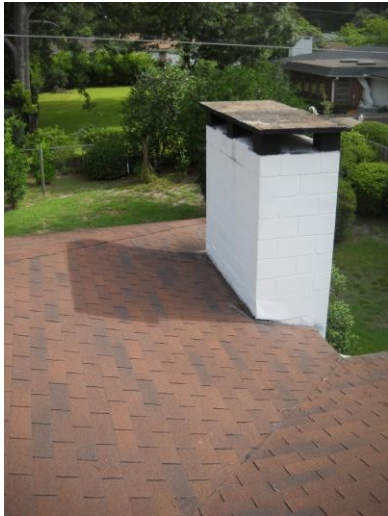
Block chimney is capped and screened

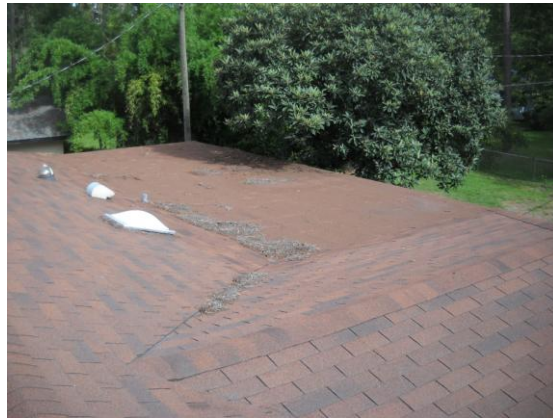
The sunroom roof is nearly flat and is covered with a good quality bitumen roll roofing material. The roll roofing material should also last another 10+ years.

Bitumen roll roof at rear patio room

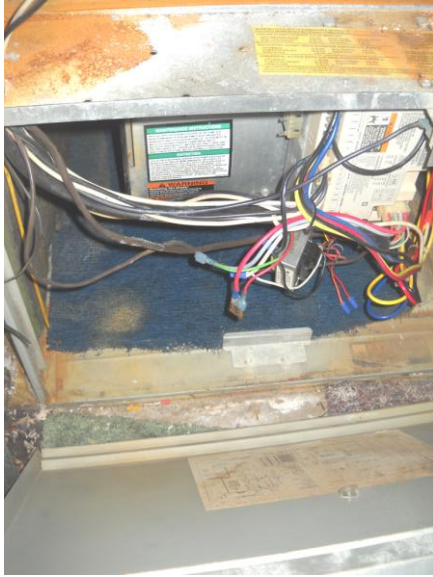
The AC filter is at the lower panel the furnace. The washable 20" x 25" filter should be cleaned every 1-2 months. Proper filter maintenance will help the AC perform better and cause less stress on the expensive equipment. The furnace closet also has proper combustion air pipes to the attic.

Washable AC filter at furnace

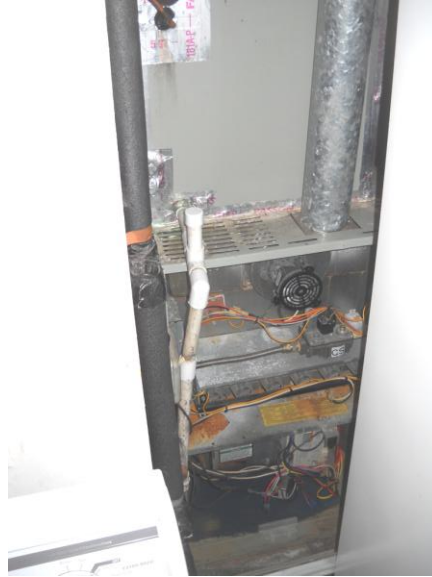
The gas-fired furnace is in the laundry room and was difficult to access due to the fridge stored in the room. The furnace has an electronic ignition system, but did not fire. The thermostat for the AC system is designed for a split system heat pump, not a gas furnace and may be part of the problem. An HVAC specialist should assess the furnace problem.

Gas furnace in laundry room

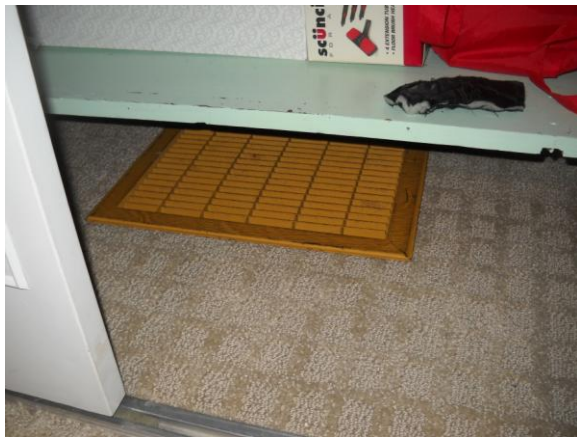
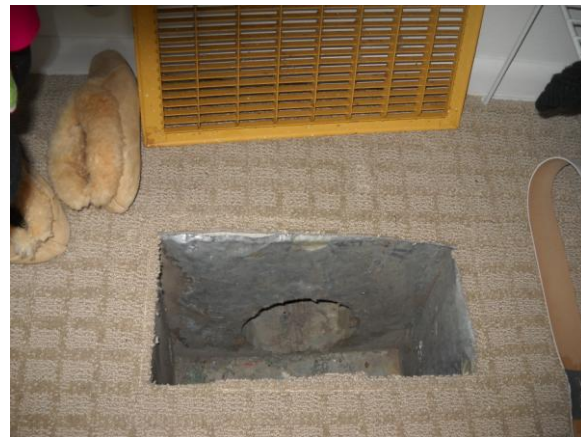
Ductwork in the attic was in good shape. Return ductwork has been routed through the slab. Return vents are in closets and need to be kept free of obstructions to allow proper airflow. The lack of access to the through-slab return can be a problem, and the system will be more prone to drawing radon gas into the home through any breaches in the return ductwork.

Return vents through slab at closets

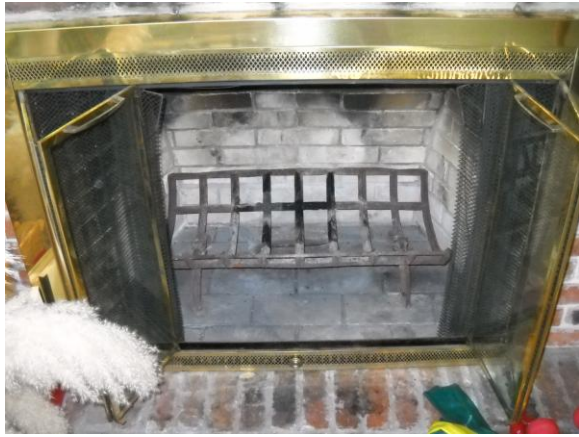
The wood-burning fireplace was very clean and in excellent shape overall. The damper worked properly and should be left closed when the fireplace is not in use to prevent conditioned air loss.

Fireplace is in good shape

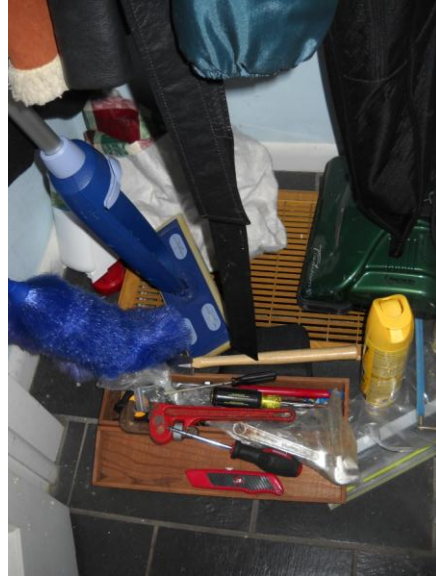
- Need to keep floor returns clear
