## Home Inspection Report

June 29, 2010

4410 NW 19<sup>th</sup> Avenue

Gainesville, FL (Suburban Heights)

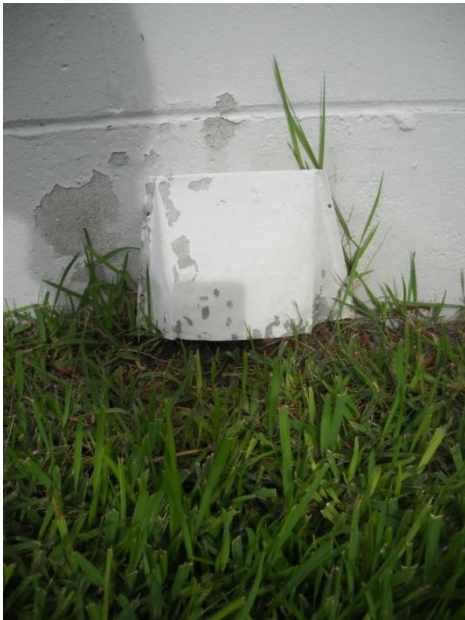
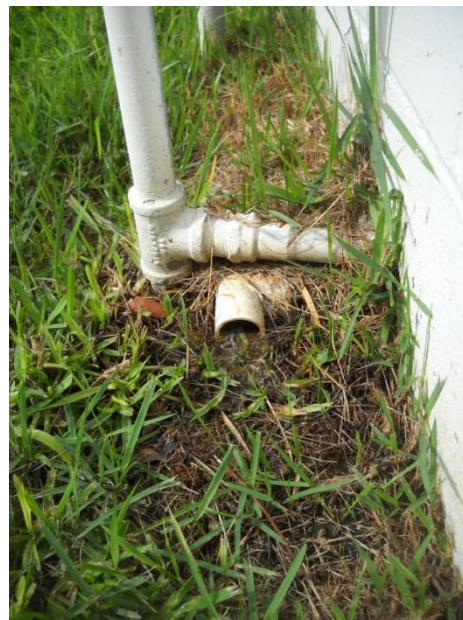
Dryer vent and condensation line terminate too close to grade (east side of home)

There is a bleach port at the condensation line (PVC line next to the air handler) to help keep the condensation line from clogging. Pour a quarter-cup of bleach down the bleach port 3-4 times each summer to prevent blockage. The condensation line terminates at the east side of the home and should be extended at least 6" above grade.

The dryer vents directly through the lower east exterior wall. The dryer vent will need to be cleaned out every couple of years or whenever drying time takes longer than normal.

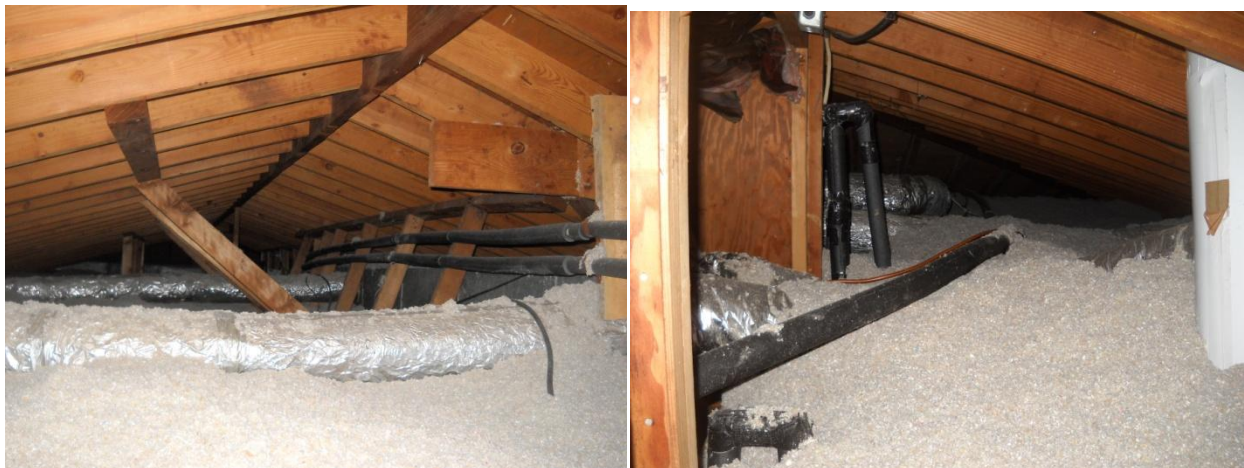
R-19 to R-30 loose-fill wood fiber insulation in attic - Properly insulated CPVC re-pipe through attic

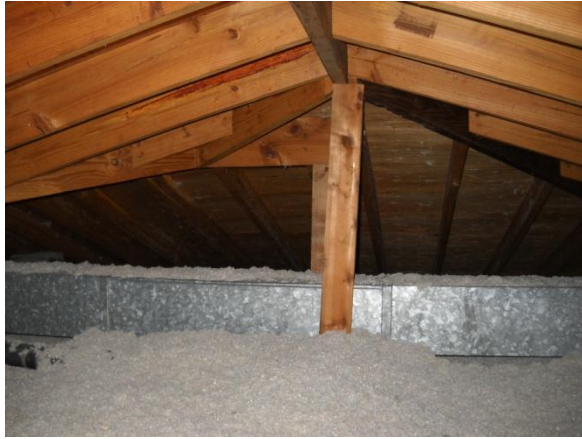
Rafter system for roof

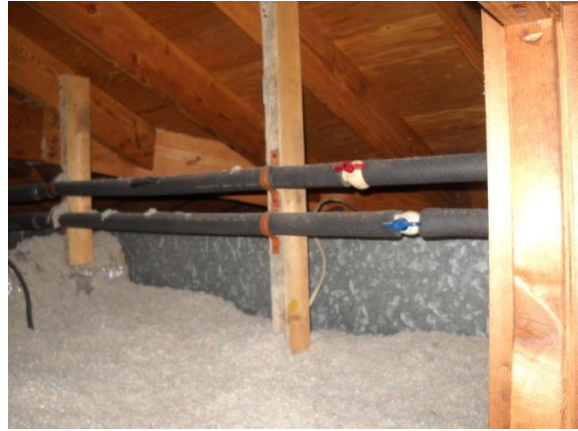
Shut-off valves in attic above laundry room

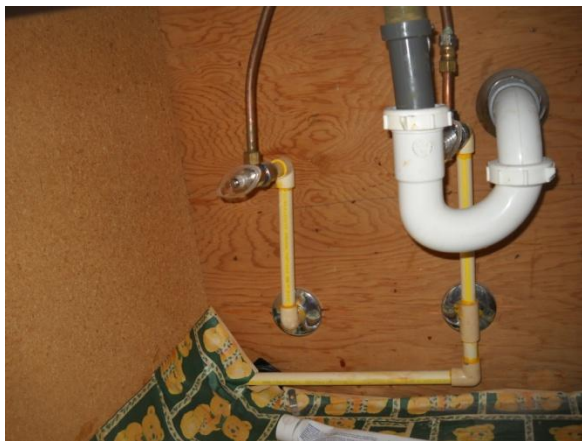
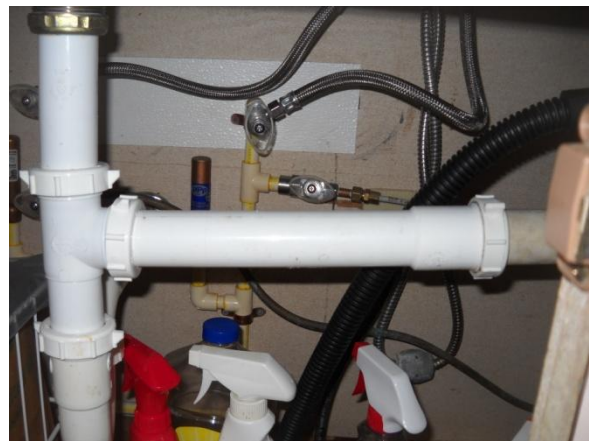
Whole house re-pipe with CPVC

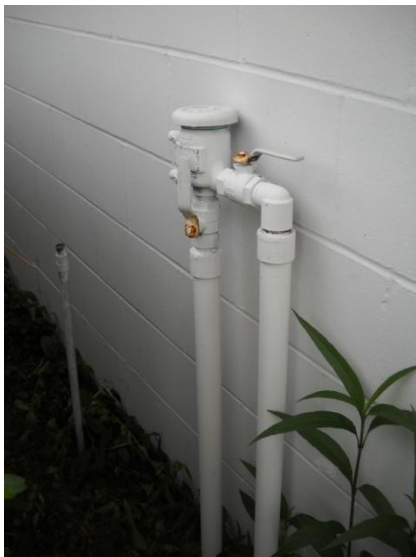
Backflow preventer at SW exterior wall -

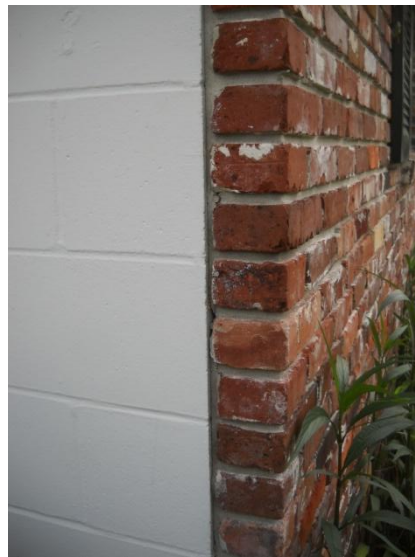
Brick face at front walls

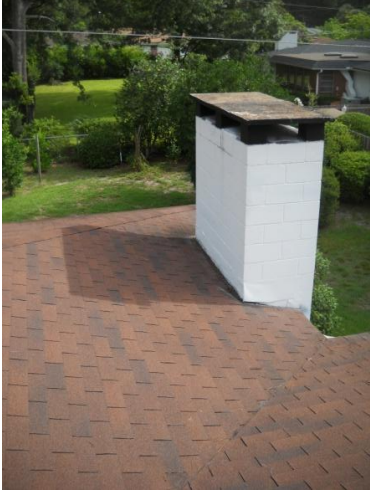
Block chimney is capped and screened -

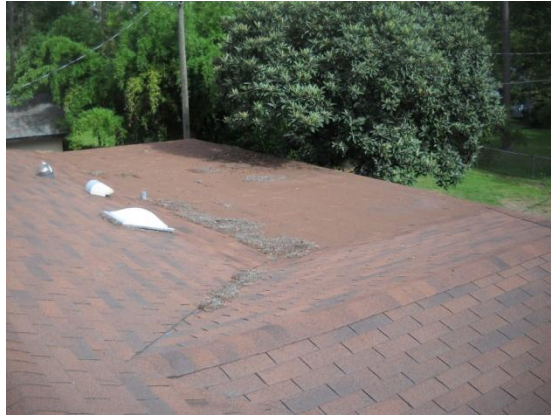
Bitumen roll roof at rear patio room

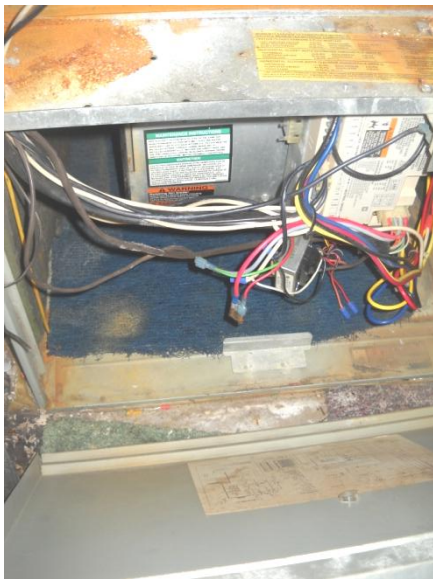
Washable AC filter at furnace -

The AC filter is at the lower panel the furnace. The washable 20" x 25" filter should be cleaned every 1-2 months. Proper filter maintenance will help the AC perform better and cause less stress on the expensive equipment. The furnace closet also has proper combustion air pipes to the attic.

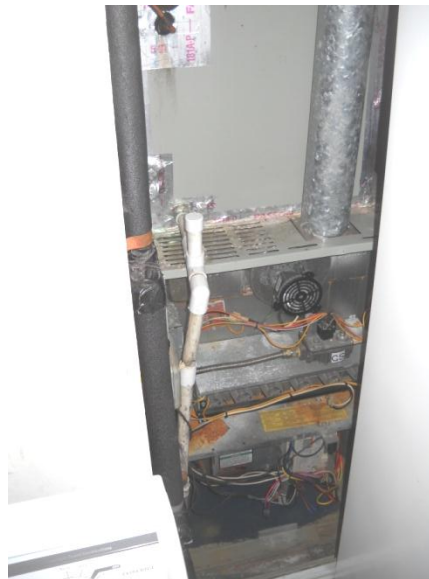
Gas furnace in laundry room

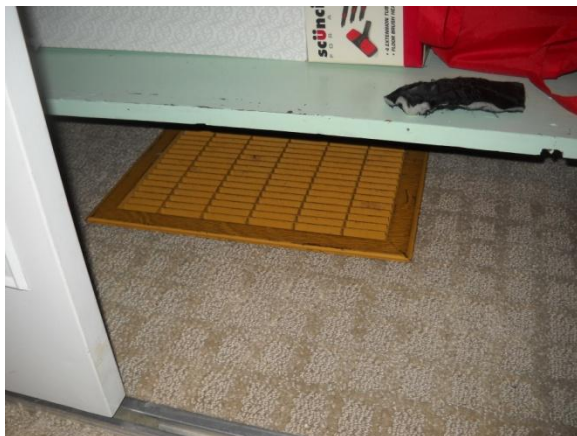
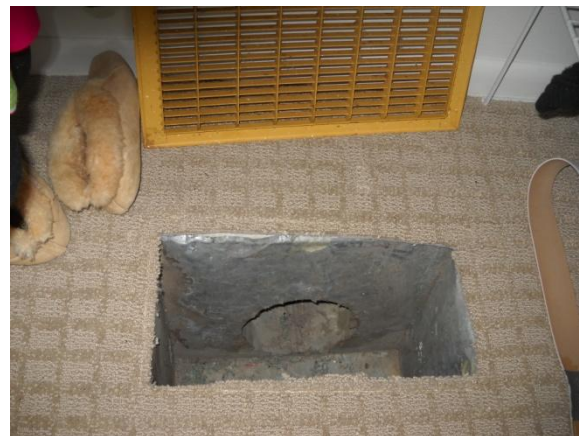
Return vents through slab at closets

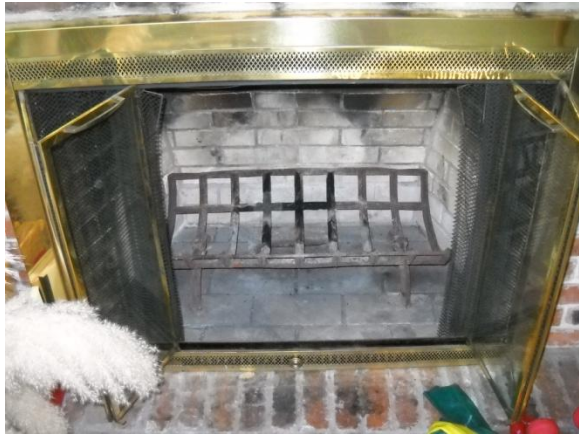
Fireplace is in good shape

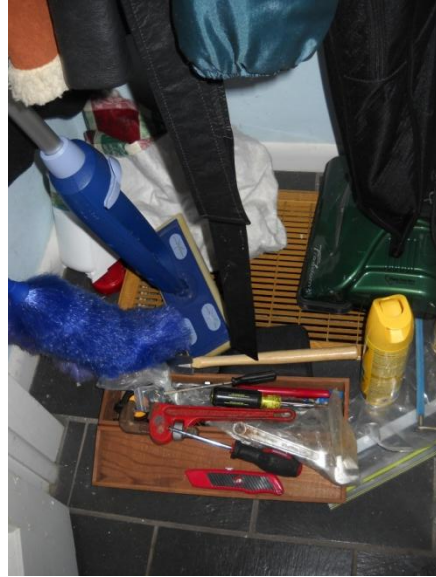
- Need to keep floor returns clear
