HELLSTROM HOME INSPECTION SERVICES, INC.

Home Inspection Report

June 29, 2010

4410 NW 19th Avenue

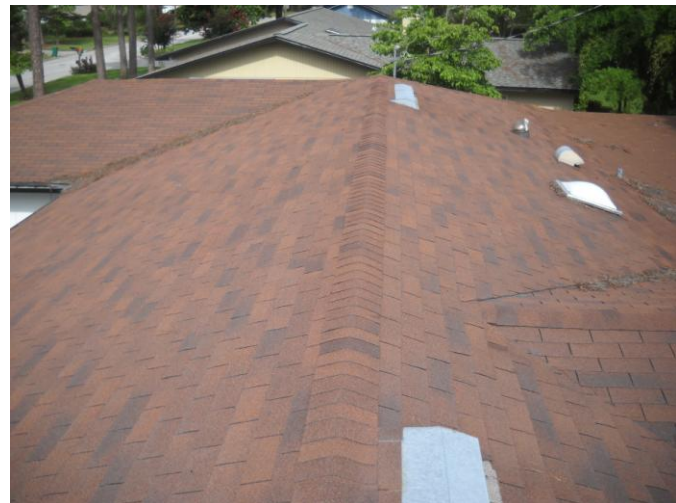
The roof is covered with 3-tab composition fiberglass shingles. The shingles appear to be about 6-8 years old, are in excellent shape, and will have another 10+ years life remaining. There were no damaged or missing shingles and no signs of roof leaks, but there are 6 or more nail heads protruding through the roof shingles at different areas around the rooftop and all exposed nails should be tarred over to prevent leaks. .

3. There were no damaged or missing shingles and no signs of roof leaks, but there are 6 or more nail heads protruding through the roof shingles at different areas around the rooftop and all exposed nails should be tarred over to prevent leaks.
