## Home Inspection Report

June 29, 2010

4410 NW 19<sup>th</sup> Avenue

Gainesville, FL (Suburban Heights)

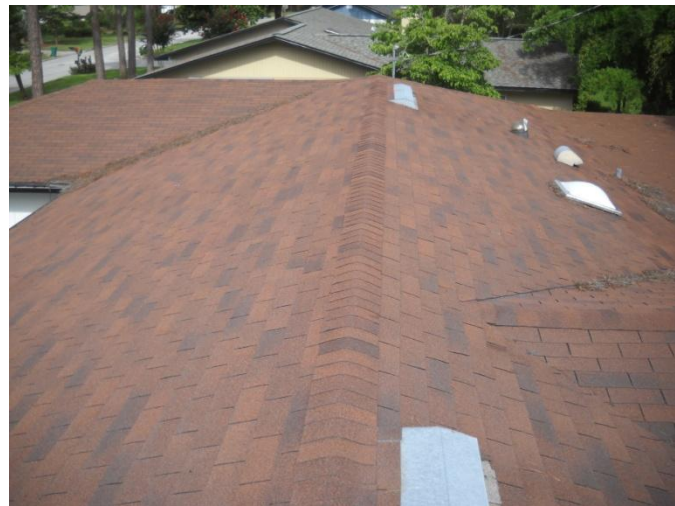
The roof is covered with 3-tab composition fiberglass shingles. The shingles appear to be about 6-8 years old, are in excellent shape, and will have another 10+ years life remaining. There were no damaged or missing shingles and no signs of roof leaks.

Plywood roof decking was in good condition through the attic. The roof system is raftered and showed no flex. Attic insulation prevented a full inspection of the roof eaves and there was no way to inspect roof decking at the sunroom.

The roof system is 80% hip-style and should qualify for a homeowner's insurance discount.

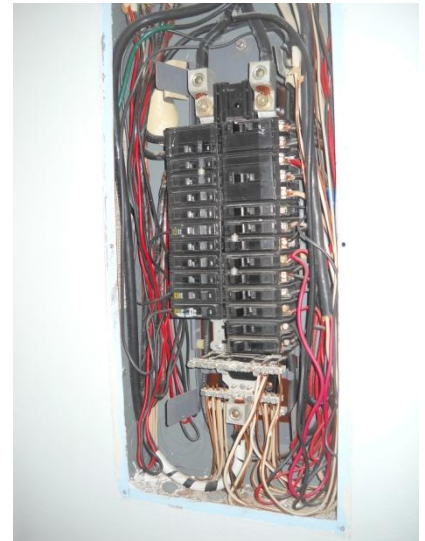
The home is serviced by three-wire, fully ground service. There is a 150-amp, 120-240 Volt Square-D main panel in the bedroom. The panel has circuit breakers, and is labeled for safety and convenience. The panel had no burned or frayed wiring. All branch wiring is copper.

The home wiring is original, but is grounded at all outlets.

There is updated GFCI protection at the bathrooms, garage (at one outlet only), and at the kitchen outlets near the sink.

There is a carbon monoxide monitor in the home at the east master suite because of the gas equipment. CO monitors are excellent safety features with any home with gas appliances.

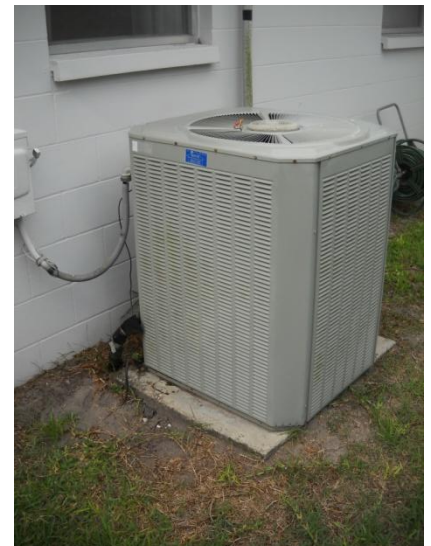
The home has a central heat and cooling. A Trane gas-fired furnace provides the heat and a Trane air conditioner provides cooling. The AC unit is located at the back of the home and is set on a level pad. The unit has a 5-ton cooling capacity, which should be plenty adequate for the home.

In the cooling mode, I look for a temperature difference (split) of at least -18 degrees between input and output. The AC cooled well at about -21 degrees.

Air conditioner units generally last 12-15 years. The cooling SEER (Seasonal Energy Efficiency Ratio) for the AC unit is a 10, which will provide average energy savings, but will not be as energy efficient as now required (13 SEER has been required since 2006). If/when one of the AC appliances is

replaced, both may need to be replaced to be compatible with new energy standards.

I also recommend annual AC service (in the spring or fall, costs about \$100). The routine maintenance will help with the efficiency and longevity of the equipment.
